# Roxhill Wetland Hydrology Restoration: Pilot Groundwater Block Design

This design is the outcome of a community led wetland restoration project, restoring wetland function

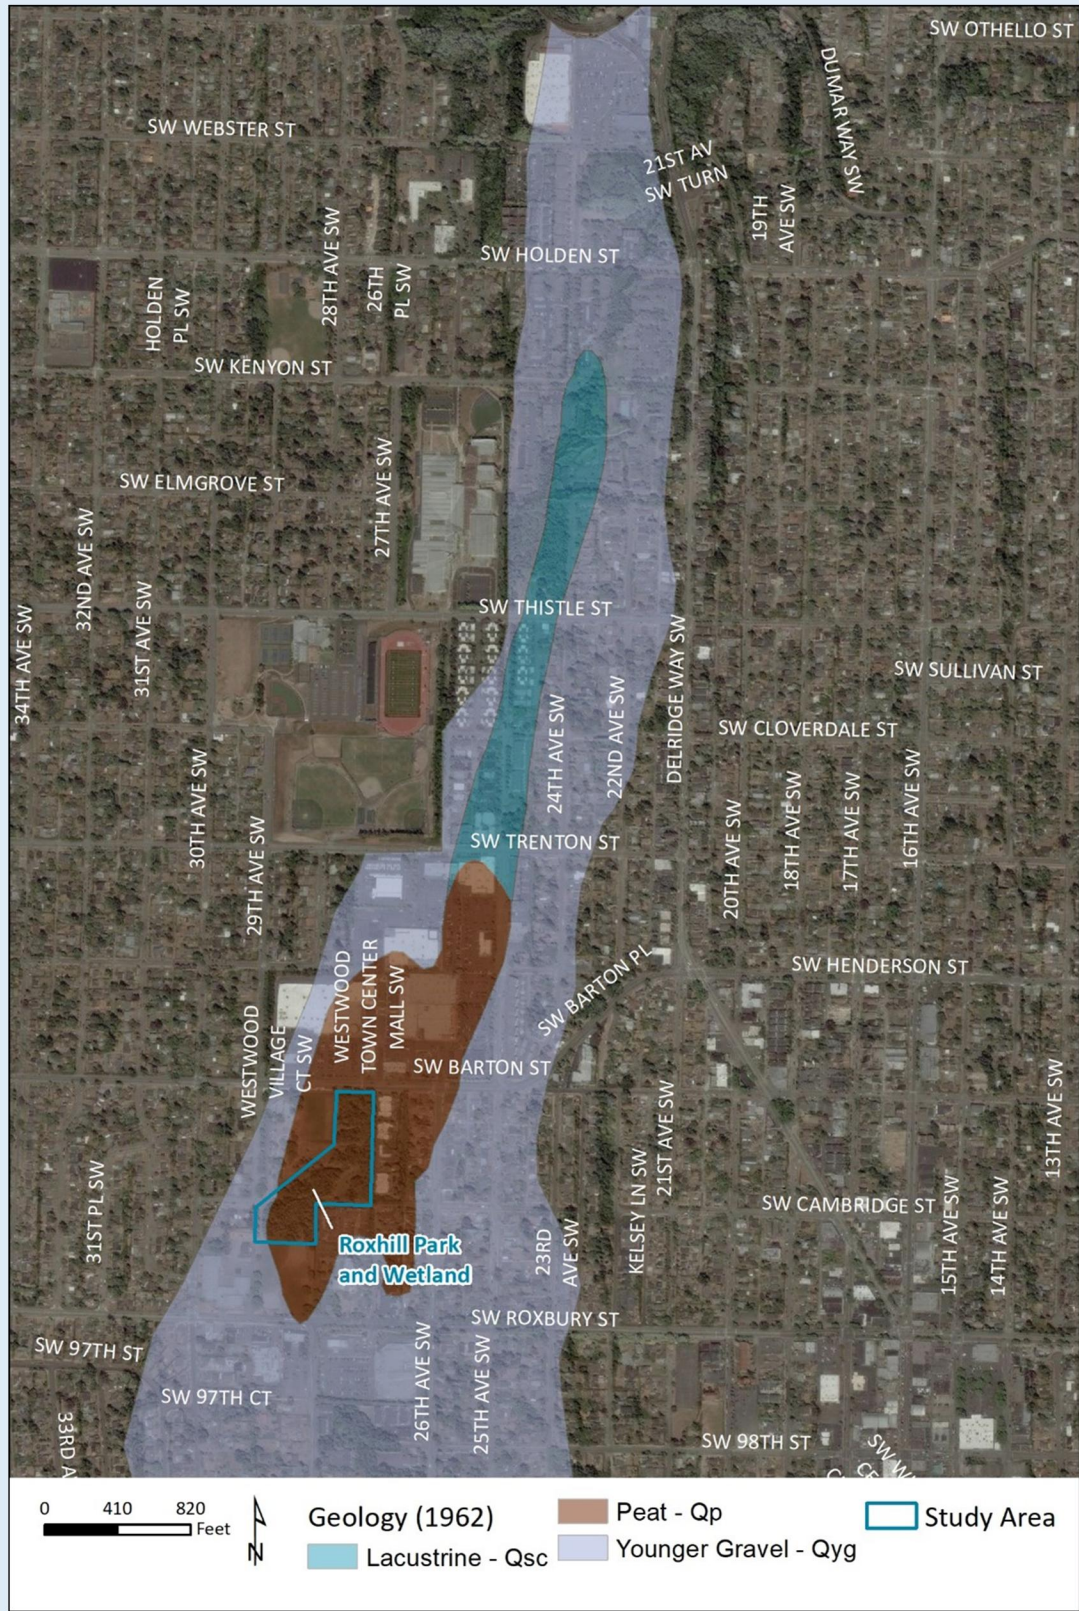
Figure 2 . Geologic context of Roxhill Park and wetlands.

The Roxhill wetlands are the historical headwaters of Longfellow Creek, occupying a depression within fine-grained glaciolacustrine sediments deposited after the last glaciation, approximately 14,000 years ago. The wetland system has undergone a number of significant changes after European establishment of the City of Seattle. Our best evidence for the former extent of the wetland is the mapped extent of Peat (symbol Op) shown on a 1962 geologic map of the South Seattle Quadrangle by the United States

- Note that only the indicated units were digitized; the units shown are generally surrounded by glacial till (not shown).
- Since informal groundwater and wetland monitoring started in 2019, there has been no evidence of surface water within Cells 1 to 3. Surface flows from the Upper Basin (south of cell 4) have been observed to enter the Cell 4 during significant storm events but infiltrate within 25 feet of the trail bridge at the upstream end of Cell 4.
- 2021-2022 groundwater monitoring revealed that groundwater is typically 3.5 feet to 5 feet below the soil surface (see Figure 3 ). Wetlands are typically sustained when groundwater is within 1-foot of the soil surface. A 2022 formal wetland delineation of Roxhill bog found that the vast majority of the bog is no longer technically a wetland.

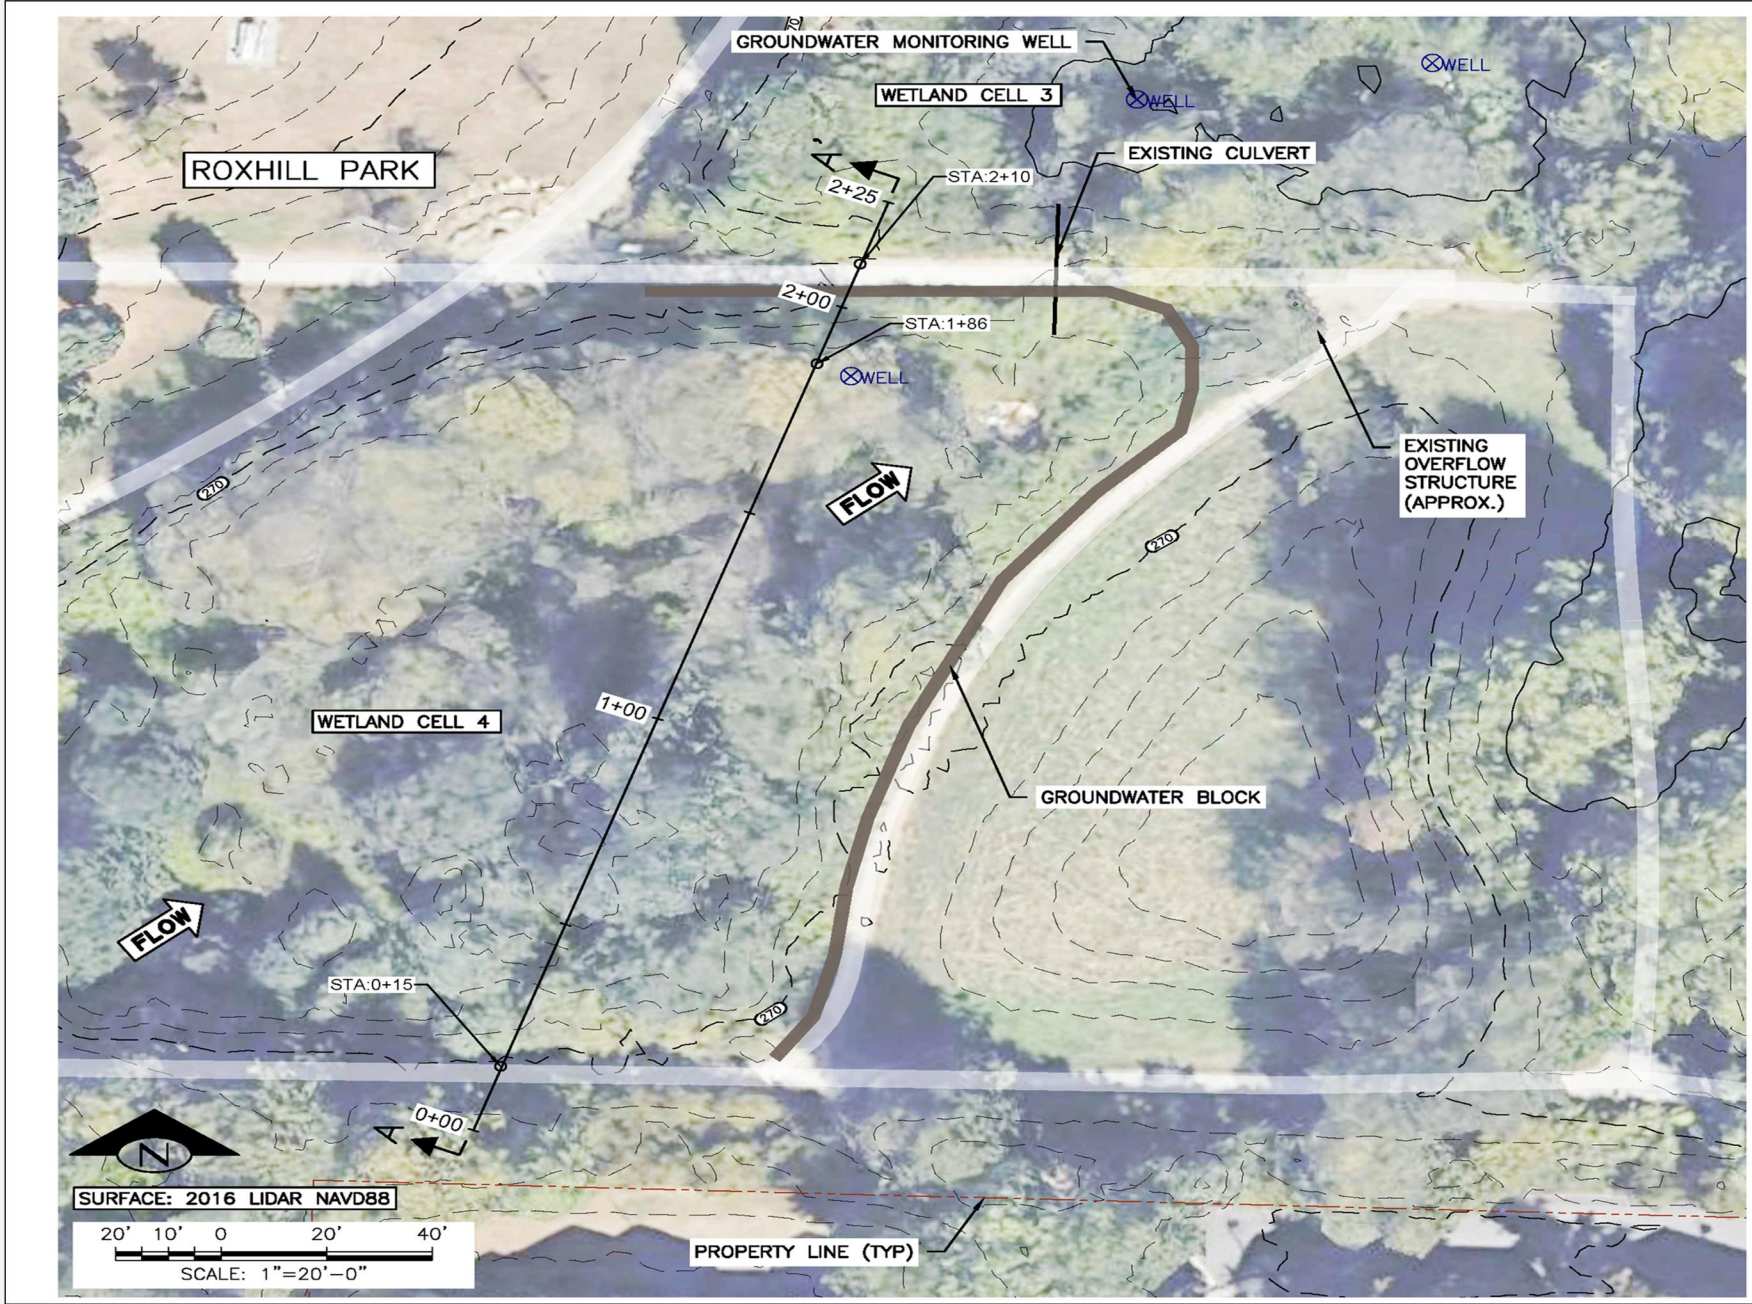
Restoring wetland hydrology within the highly modified urban context surrounding Roxhill bog is not a easy task. When constructed, the proposed groundwater block in cell 4 will be a unique pilot project, testing whether groundwater flows are infiltrating deeper into the soil profile or running laterally underground and off site (see plan view). If increases in groundwater elevations are observed, then additional groundwater blocks will increase local groundwater levels and significantly restore wetland hydrologic processes (see illustrated cross section view).

- The proposed pilot groundwater block project consists of installing a vinyl sheet pile groundwater block between Cell 4 and Cell 3 to elevation 267 (see plan and cross section views).
- The block would generally be aligned along the edge of existing paths, limiting disturbance to the park and vegetated areas and intersecting known groundwater flow path.
- An important element of the pilot project will be the development and implementation of a focused monitoring program. The monitoring program will utilize the existing groundwater monitoring network to track groundwater response. The monitoring should occur for a full wet season (Oct-May) following pilot project installation.
